# **Dispersal of microplastic from a modern artificial turf pitch with preventive measures**

**- Case study Bergaviks IP, Kalmar**

**Status: Report**

**Date 2019-10-24**

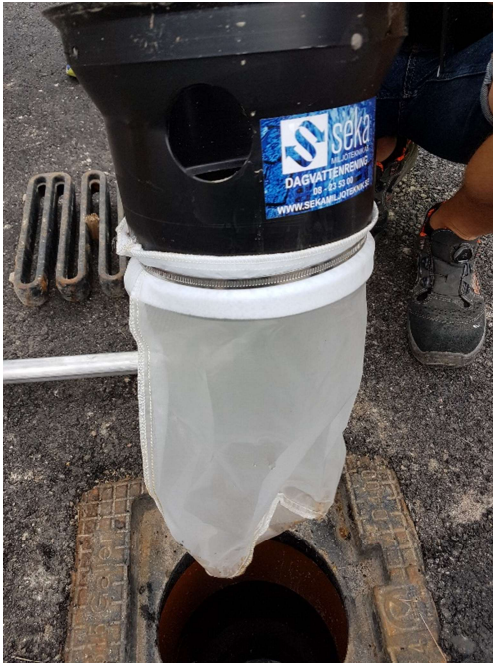
Figure 3. Granulate trap at Bergaviks IP

- Granulate traps were installed in all stormwater drains around the pitch ( $>200\text{ }\mu\text{m}$ ), figure 3 below
  - Enable measurement of microplastic  $> 200\text{ }\mu\text{m}$  which reaches the open stormwater drains and is captured in the granulate traps

The granulate traps have been emptied on two occasions; March 2019 and September 2019. The amount of microplastics was determined by drying and weighing.

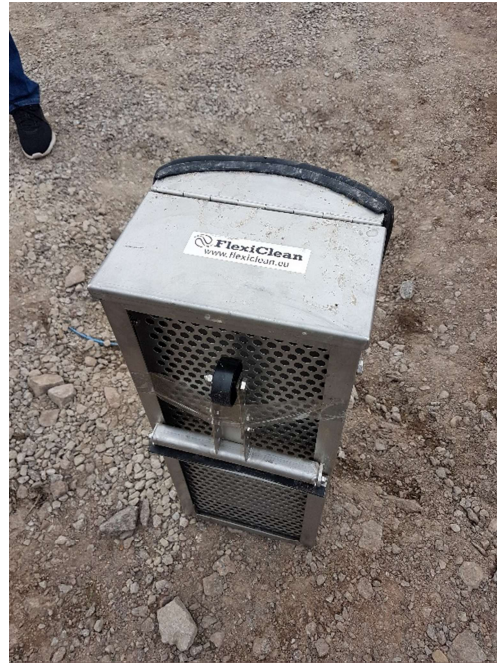
Figure 4. Granulate filter before installation in drain at Bergaviks IP

- Granulate filter which captures microplastic  $> 100\text{ }\mu\text{m}$ , figure 4 above
  - Prevents microplastic  $> 100\text{ }\mu\text{m}$  being dispersed with the surface water
- Winter lining to pile up snow on the pitch instead of hard surface
  - Minimise the spread of granulate from the pitch as a result of snow clearing
- Fence around the entire pitch with a board at the bottom against the ground
  - Minimise dispersal outside the fence along the ground

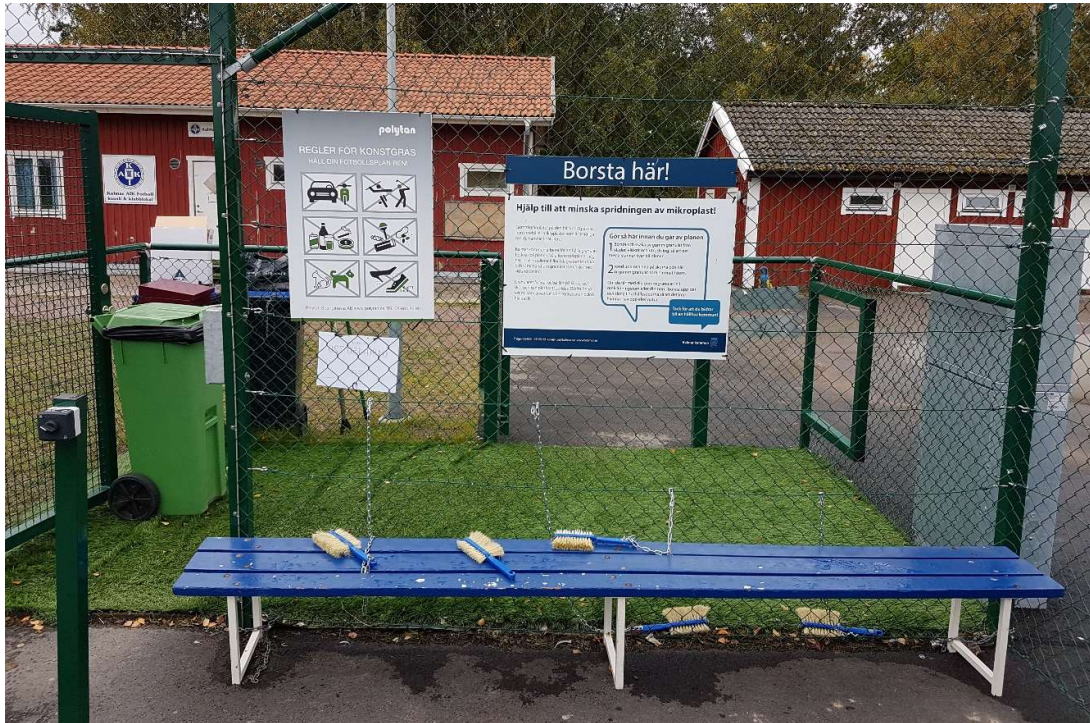
Figure 5. Brushing station with info sign at entrance/exit of Bergaviks IP

- A main entrance/exit with brushing station and information sign for players, figure 4 below.
  - Direct players to the exit and there prevent microplastics being spread from the pitch with players
